## 4 Structural Performance

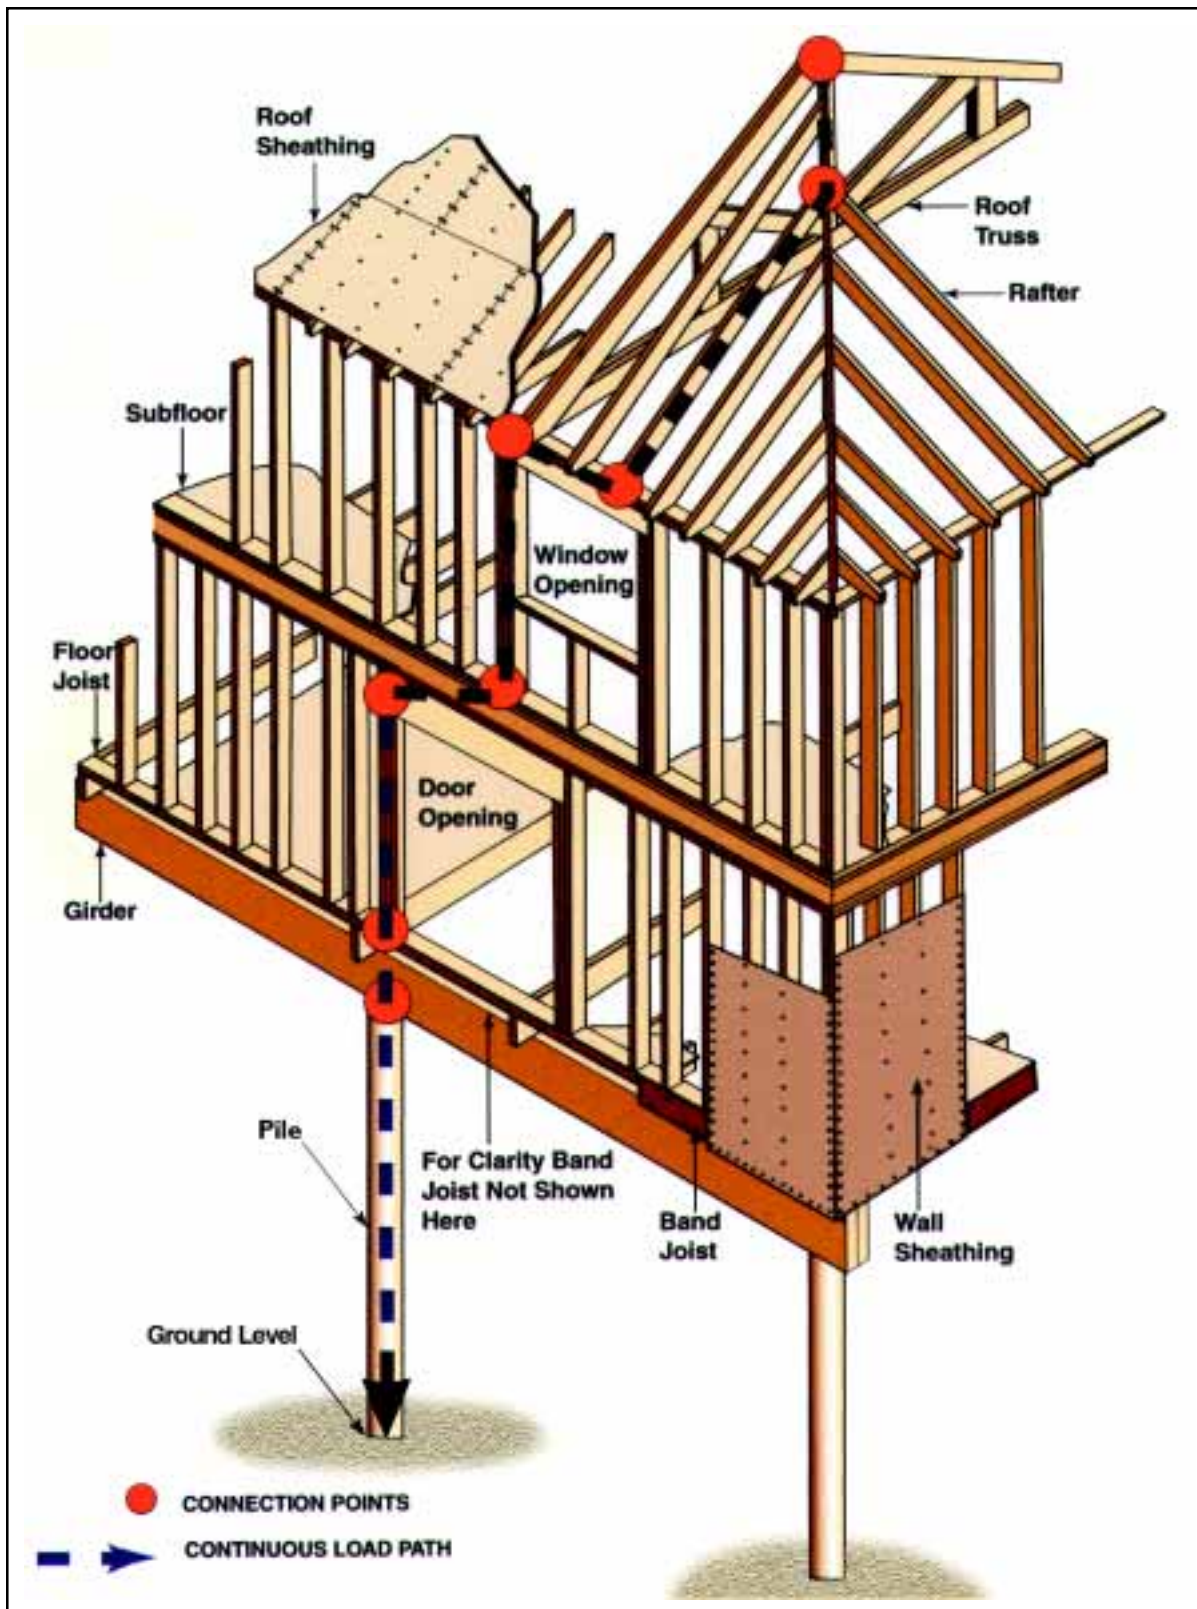
**FIGURE 4-1** If a building has a continuous load path, forces and loads acting on any portion of the building will be transferred to the foundation of the building. This transfer occurs through building structural members (i.e., columns and beams) and the connections between these members. In this figure, the load path from the roof structure to the foundation is illustrated for an elevated, two-story wood-frame building.

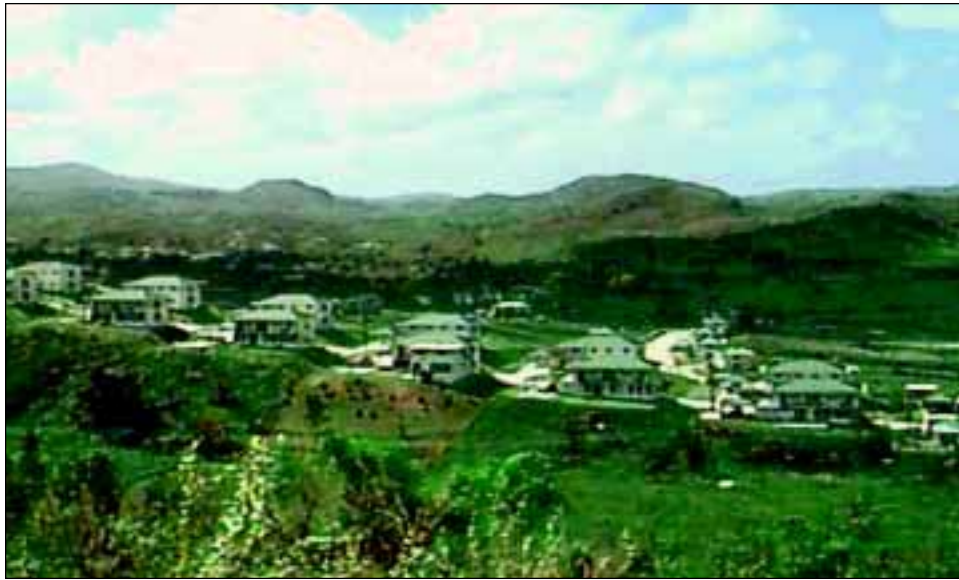
**FIGURE 4-2** A residential community constructed of concrete and masonry buildings with concrete roof structures. This community, located to the west of Luquillo experienced no complete building failures. The eye of the hurricane passed to the south of this community, placing it in the strongest wind quadrant of the hurricane.

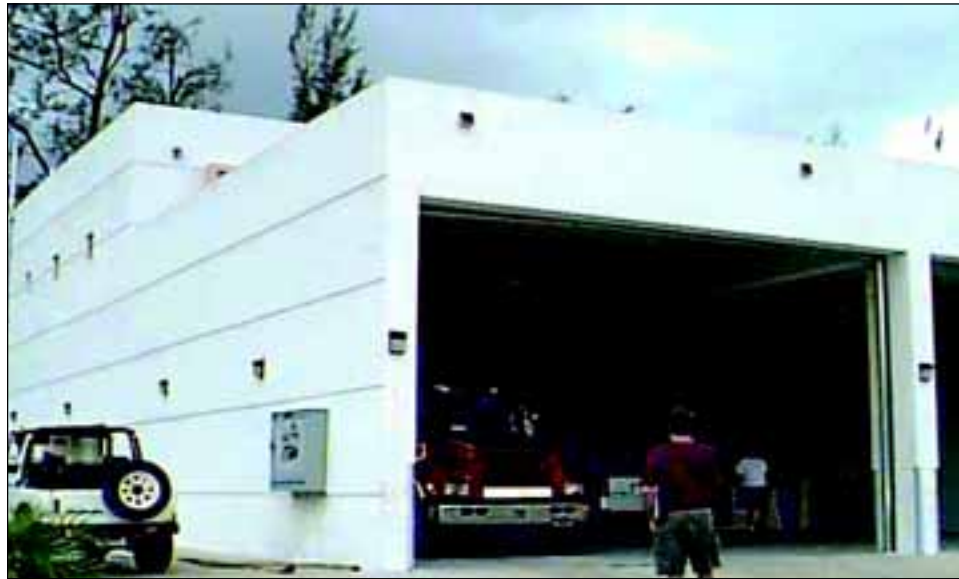
The BPAT inspected two fire stations, one in Adjuntas and the other on the island of Culebra, located approximately 20 miles east of the main island. Both fire stations had concrete roof decks. The stucco finish on both buildings prevented a direct observation of the wall systems that reportedly consisted of concrete columns with CMU infill. These structures also had open security grilles in the truck bays rather than large rolling doors. Neither station sustained structural damage during the hurricane. The Adjuntas fire station, which completed construction in 1998, featured a small percentage of exterior windows and an emergency electrical generator that was protected and enclosed within the building envelope (Figure 4-5). The BPAT was unable to determine the seismic resistance of either fire station.

**FIGURE 4-5** Fire station in Adjuntas.

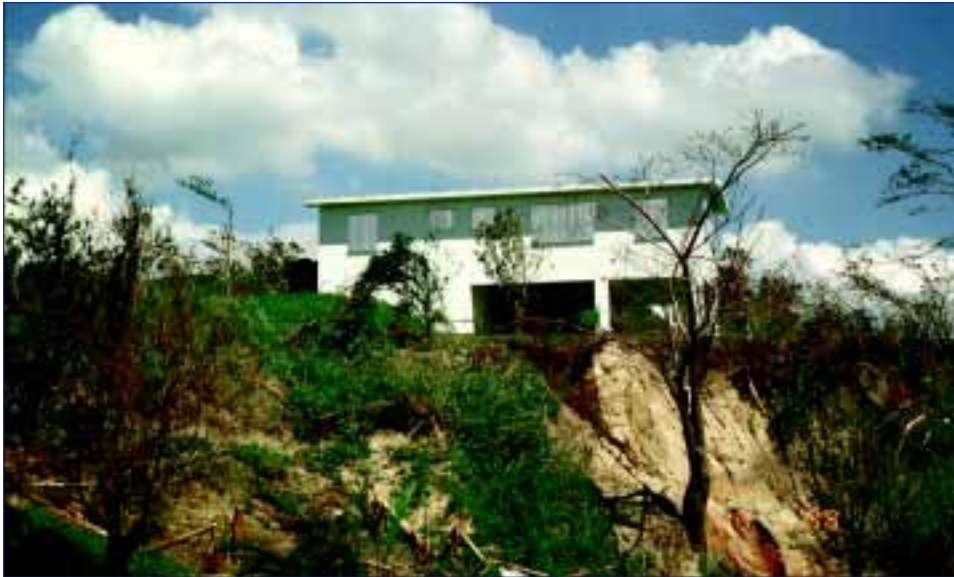
Reinforced concrete buildings (single-family homes) with reinforced concrete roof decks generally did not sustain structural damage (Figure 4-6). First floor walls in reinforced concrete residential buildings were usually 6-in to 8-in thick and constructed of reinforced concrete columns with masonry infill, or were solid concrete walls. CMU walls had varying amounts of reinforcement within the cells. Roof decks typically were flat and constructed of reinforced concrete. Many were exposed concrete with no roof covering. This structure type performed extremely well. Even buildings with unprotected wall openings did not experience structural damage.

**FIGURE 4-6** Residential home constructed of reinforced concrete and masonry with a reinforced concrete roof deck in the mountains outside Adjuntas.

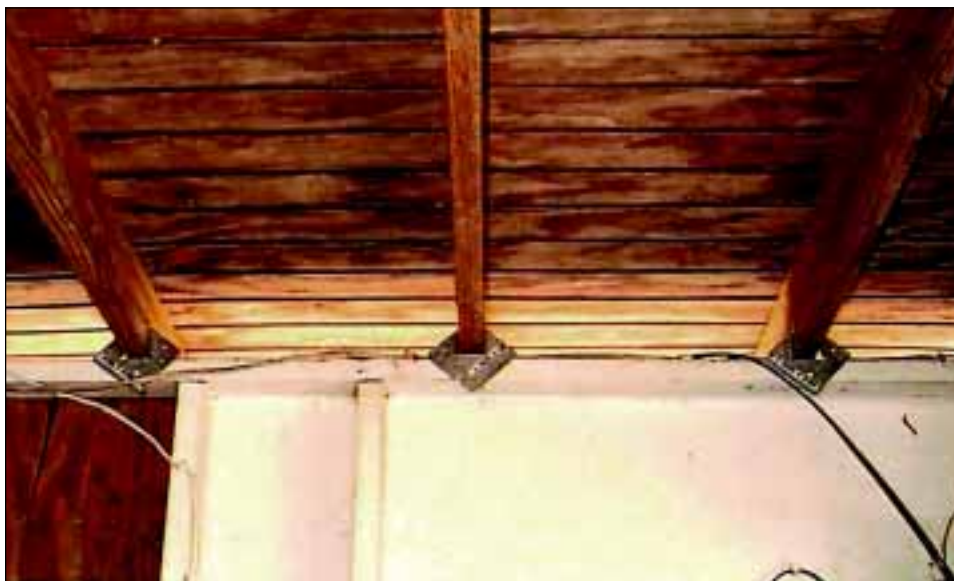
Some residents installed hurricane clips as part of their mitigation efforts after hurricanes in 1995 and 1996. Figure 4-12 shows positive mitigation efforts implemented in a wood-frame house on the island of Culebra in 1996, as observed after Hurricane Georges. Utilization of clips and straps, however, was not typical in wood-frame buildings in Puerto Rico.

**FIGURE 4-12** Hurricane clips installed in a wood-frame house on Culebra.

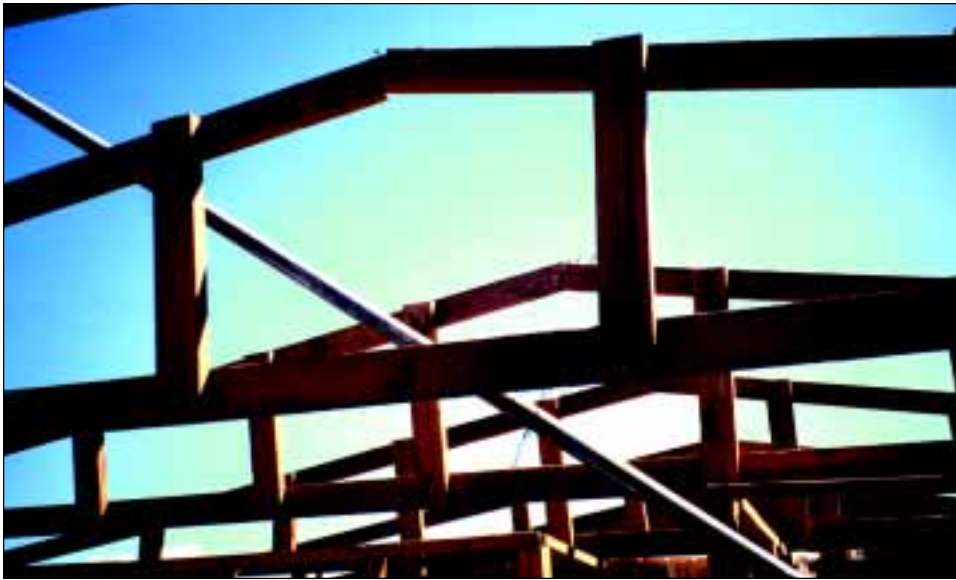
Roofs were constructed of rafters, self-built trusses or pre-manufactured trusses. Rafter roof systems typically used nominal 2-in by 4-in to nominal 2-in by 6-in members. Lateral support or bracing was only provided by nominal 1-in by 3-in to nominal 1-in by 6-in nailers. Roof rafters and trusses were spaced on intervals ranging from 2-feet to 4-feet on center. Roof nailers for metal roof panels were observed on most wood-framing at 3-feet to 4-feet on center (Figure 4-16). Nailers did not typically provide adequate load capacity for the 110 mph design wind indicated in the 1987 amendment to Planning Regulation 7. In addition, the nailer/joist connections and the nailer/rafter connections observed generally were only connected with one or two nails. This simple nailed connection does not provide adequate resistance to shear and uplift forces that may be experienced during a high wind or seismic event. Figure 4-17 shows a typical self-built, wooden roof truss.

**FIGURE 4-17** Example of a self-built, wooden roof truss.

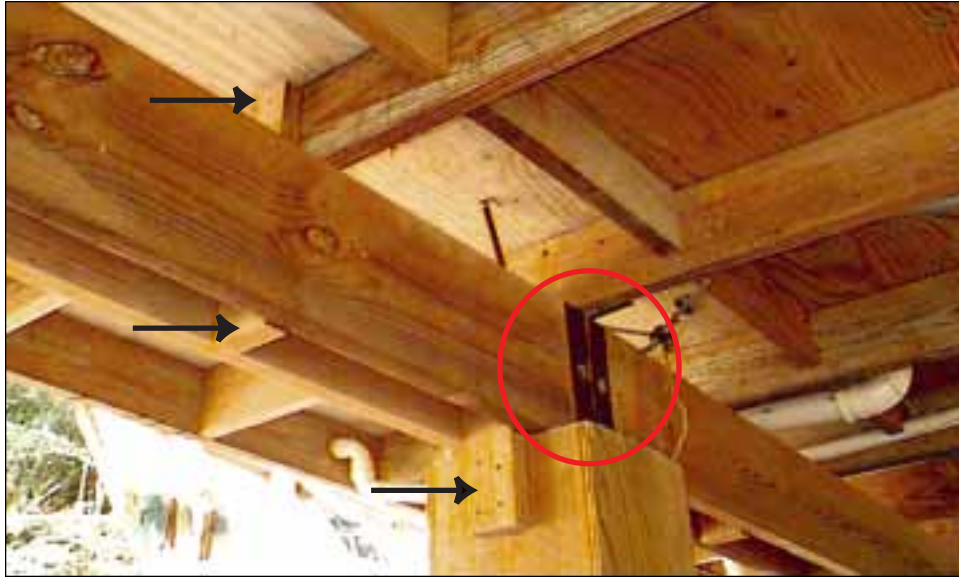
The wood-frame buildings the BPAT inspected had varying floor systems and floor system-to-foundation connections. Many floor systems that remained in place after the wood-frame building constructed above was destroyed had minimal connections between the floor system and the foundation. Success of these connections is believed to be due to the failure of the roof and walls before the failure of these typically non-engineered connections between the floor system and the foundation (Figure 4-18). In a few homes, engineered floor system-to-foundation connections were observed (Figures 4-19 and 4-20).

**FIGURE 4-19** Example of an engineered connection between the floor beam and a concrete column (concrete column is enclosed in plywood). Vertical members (identified by arrows) provide continuous load path from floor joist to floor beams. Floor beams are connected to concrete columns with metal straps (circled). This house was located on the island of Culebra.

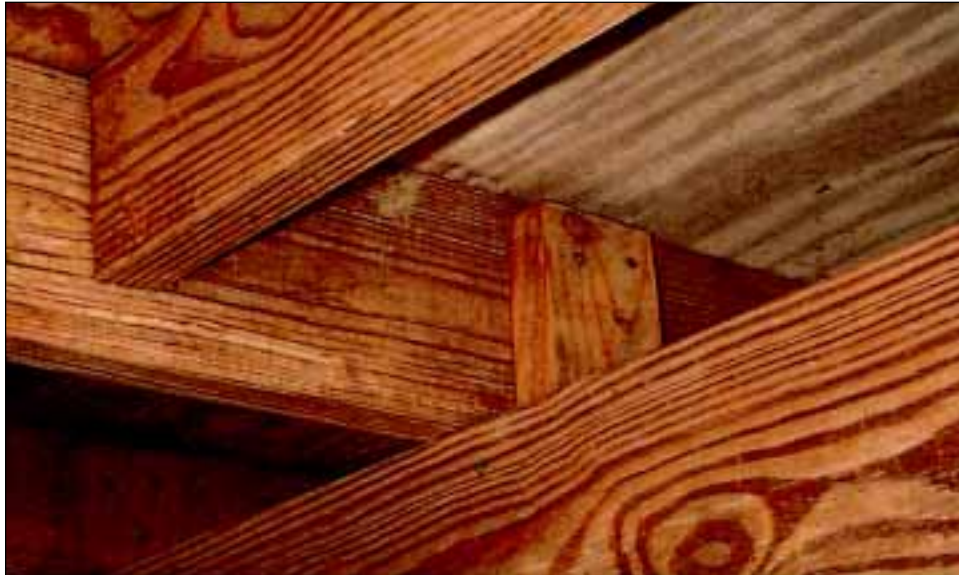
**FIGURE 4-20** Example of a successful wood connection between support beam and floor joists. This is the same house shown above in Figure 4-19.
